**On-site reconstruction:
Post-flooding
reconstruction in Morropón,
Piura**

On-site reconstruction: Post-earthquake reconstruction in Chuschi and Quispillacta, Ayacucho

On-site reconstruction: post-earthquake reconstruction in Moquegua

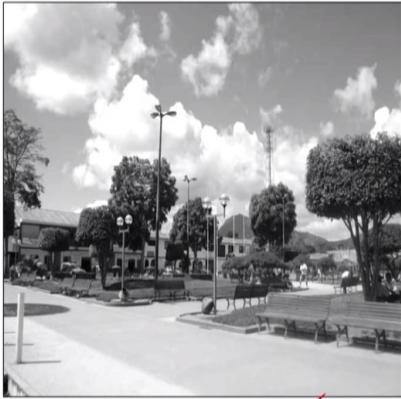
Figure 13.2 The main square in Alto Mayo

Public areas are neglected, except for the main squares which have adequate lighting, trees and benches; secondary roads are usually unpaved and have no trees.

And which has been you know, you can see the secondary roads are not normally paved and they do not have any trees or plantation except for the main squares they have not concentrated much on the public spaces. So, they also the migrants have also created problems, you know they started settling down on plots and outskirts of the towns increasing their savings and thus creating a demand for more housing and houses.

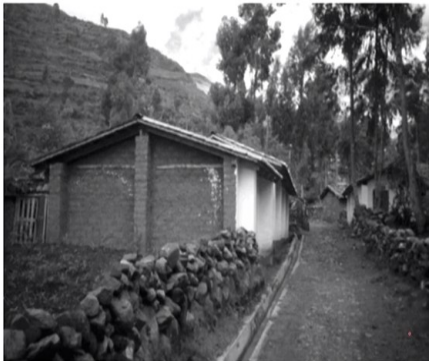
Figure 5 Improved adobe house in Ayacucho, Peru. © ITDG.

And that is how the participation have ensured that they have taken the self-esteem forward. I will also discuss about the third case, which is an on-site reconstruction again and post-earthquake reconstruction in Chuschi and Quispillacta Ayacucho. So, this is an adobe house, so what they did was they have adopted because being in all these 5 or 6 settlements, the poverty is one of the common factor.

And here, what they did was they tried to train them making adobe square blocks and train them in making this adobe houses.

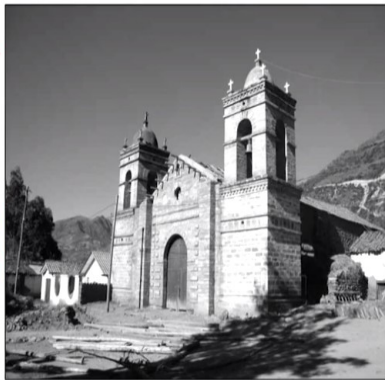
Figure 13.3 Carved stone church in Quispillacta built with the population's efforts

No improvements have been made in public areas, the streets are gradually deteriorating, the stone paths have no clean or uniform paving, ditches have not been cleaned and only a few attempts have been made to plant trees.

And how to make some improvements on it and again, here also they consulted the people what kind of beneficiaries and they make involved and all the people in making these houses and everything but what we see is there is not many improvements have been made in public areas, like you can see the streets have been gradually deteriorating, the stone parts have not clean and uniform paving and ditches have not been cleaned.

So, which means, this is where, there is a negligence on the public space itself but one interesting thing is people have invested the time and effort to actually to make this particular carved stone church in Quispillacta built because this is how one positive sign of it but somehow it has not been taken into the overall scheme, you know, how the same energy could have well better used here in making this well.
